**UNIDENTIFIED FLYING OBJECTS (UFO) FILES**

**File Title:** Investigations of Unidentified & Radar Sightings  
East Coast South Island – December 1978

**File Contains:** Interviews with people involved in the 1978 Kaikoura sightings conducted by the RNZAF preparatory to the preparation of a formal report into these sightings. File also contains technical reports from DSIR and other scientific experts and an independent report of the Kaikoura sightings by the NZ UFO Studies Centre.

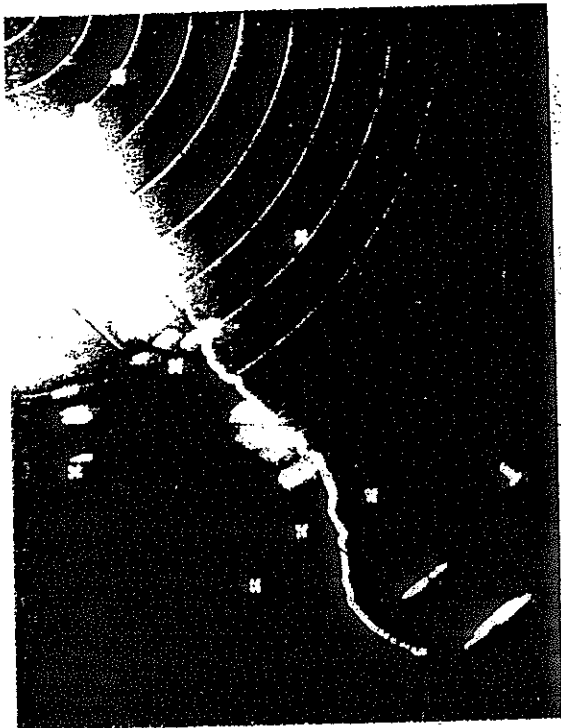
0333. RAW VIDEO. 160 MI.

BANKS PENINSULA RETURN  
AT MAX<sup>m</sup> RANGE

TWO ANOMALOUS ECHOES  
15 MI. NORTH OF BANKS P.

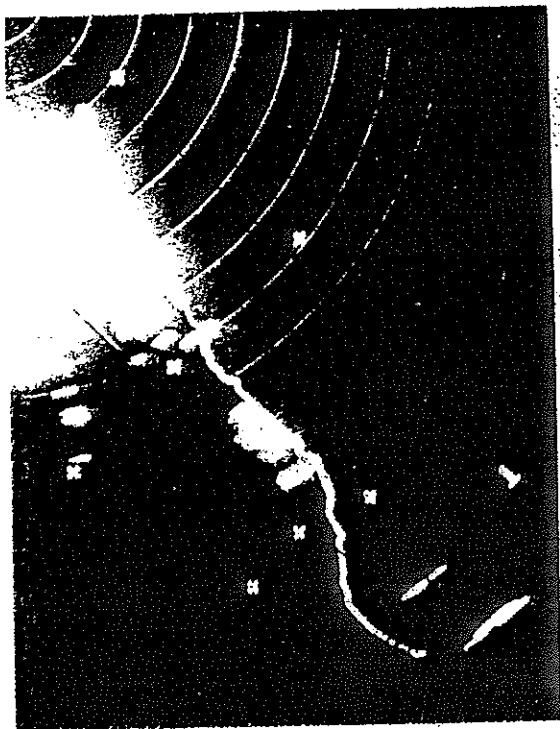
0330. RAW VIDEO. 160 MI.

BANKS PENINSULA RETURN  
AT MAX<sup>m</sup> RANGE

TWO ANOMALOUS ECHOES  
15 MI. NORTH OF BANKS P.

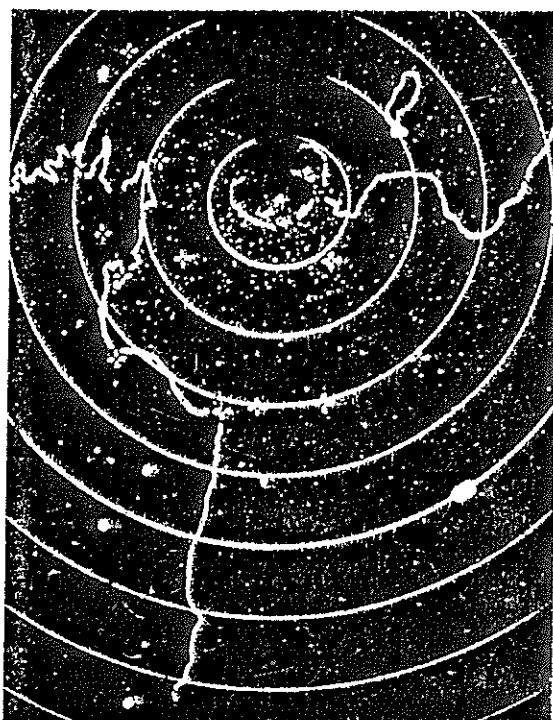
0436. M.T.I. 10 MI CIRCLES

SHIP OFF SOUNDS 36 MI.

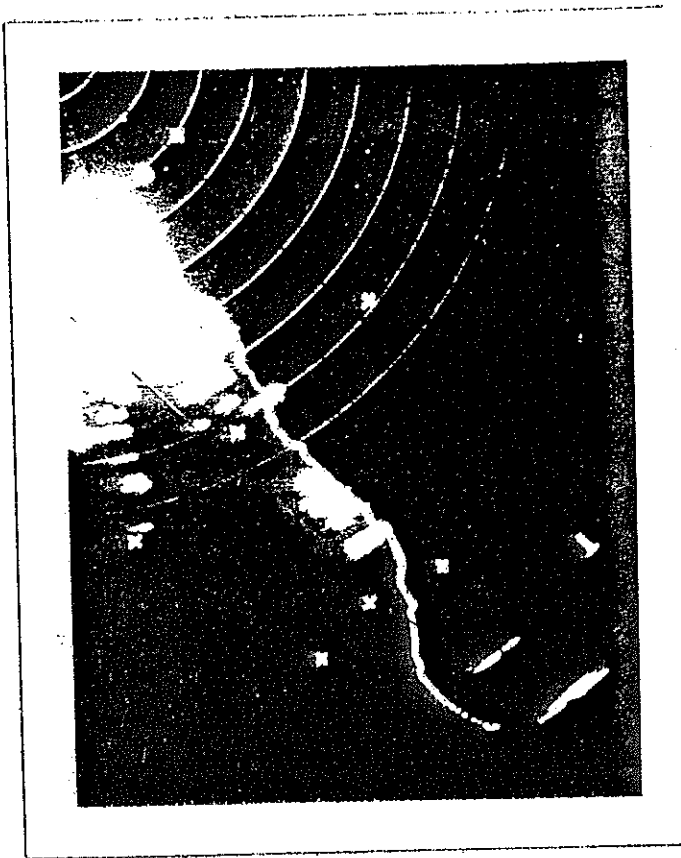
0338, RAW VIDEO. 160 MI.

BANKS PENINSULA RETURN  
AT MAX<sup>m</sup> RANGE

TWO ANOMALOUS ECHOES  
15 MI. NORTH OF BANKS P.

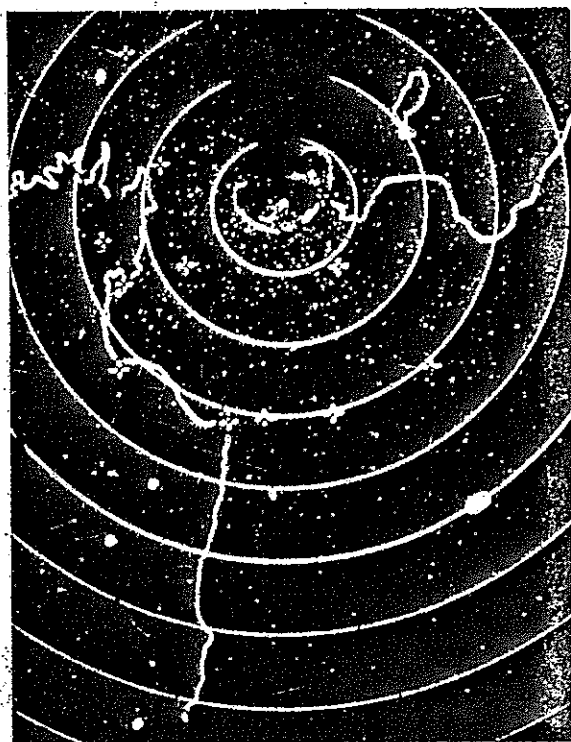
0436. M.T.I. 10 MI CIRCLES

SHIP OFF SOUNDS 36 MI.
